BKV Beyond is installed at the NSK Kielce ball bearing factory

Application Note

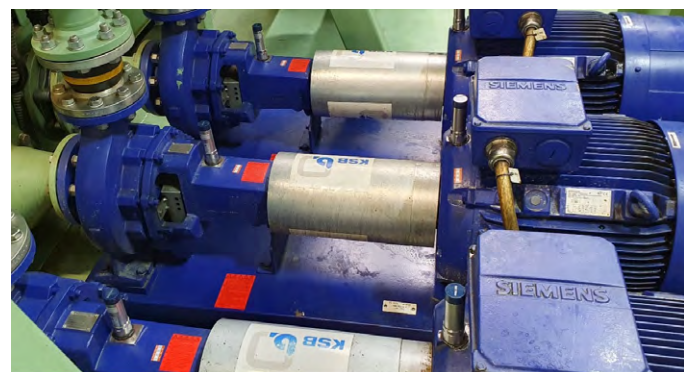
Figure 2. One unit of the water treatment installation, showing two wireless sensors on each pump.

There are two water treatment installations in the plant with three pumps each (Figure 2). One or two pumps are operating at any time for each unit with the rest on stand-by. For the very critical air treatment part of the plant, there are 10 fans (Figure 3).

Monitoring strategy Each water treatment pump included two sensors to monitor the condition of the bearings, unbalance, looseness, misalignment as well as any problems with the impellers and motor. This was accomplished with velocity and acceleration vibration signals, a high frequency crest factor measurement and temperature.

In both cases, it was determined that wireless sensors could be used, which would greatly simplify the installation. These were glue mounted on the bearing housing, so no screw holes had to be drilled and tapped. The dynamic frequency response for this sensor and mounting is sufficient for the potential failure modes to be detected.

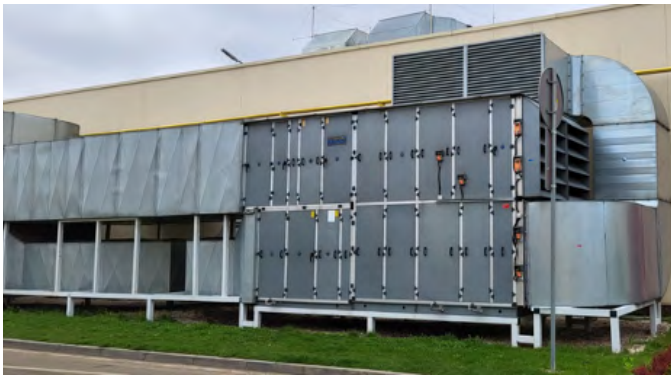
Figure 3. The critical air treatment system where 10 fans are monitored.

There was only a single sensor on the driven-end bearing housing of the fan's motor for the air treatment utility, but the monitoring strategy was similar to that for the pumps.

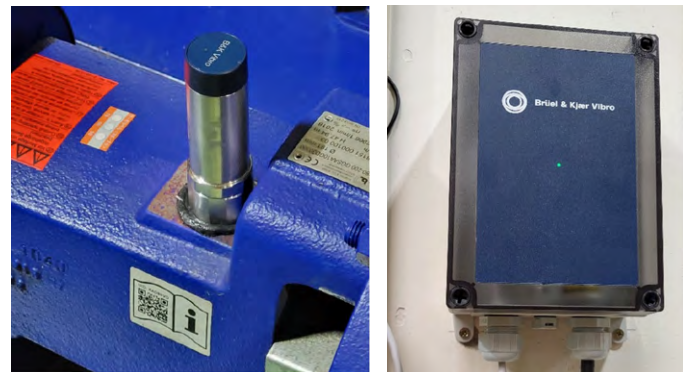
Figure 5. BKV Collect wireless sensor is shown on the left (the QR code, not visible, is on the back of the sensor). The BKV Connect gateway is shown on the right.

- **Simple installation** – No tedious wiring has to be done for the wireless sensors, and the BKV Ignite web-based software simplifies the system configuration. Once the sensors are installed, the configuration and commissioning is completed with the help of the BKV Deploy app. Here, sensor information is obtained by reading the QR or NFC codes with a mobile phone.
